**POST-REMOVAL SITE CONTROL PLAN  
TAILINGS PILES AREA  
TALACHE MINE TAILINGS SITE  
ATLANTA, IDAHO**

October 2004

**ST. JOE MINERALS CORPORATION  
AND  
MONARCH GREENBACK, LLC**

**MFG, Inc.**

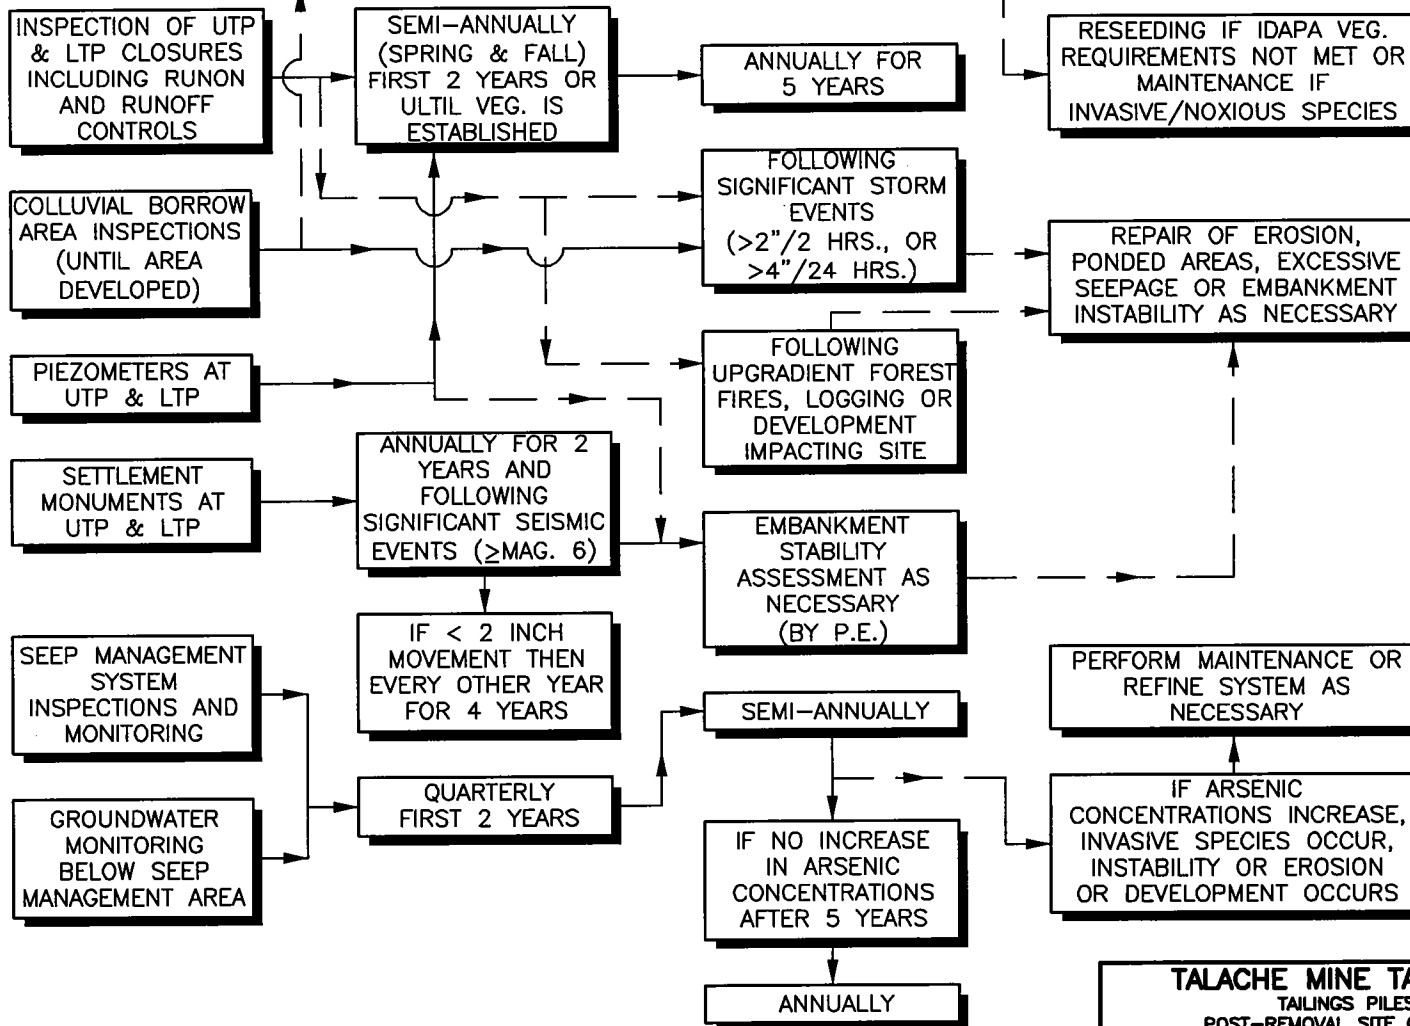
FIGURE 3

# INSPECTION/MONITORING AREA

# INSPECTION/FREQUENCY

# MAINTENANCE

This section presents the regular maintenance procedures for the Tailings Piles closure and associated runoff and runoff-control systems, and the seepage control/water management system. In addition, contingency plans are presented for major breaches, failures or post-flood conditions to maintain the integrity of the closure facilities. Maintenance procedures will normally be performed during the mid to late summer months when dry conditions prevail and surface water and seep flows are lower. Additional seeding will typically be performed in the early fall period, as necessary. An overall inspection and maintenance schedule is presented in flowchart form on Figure 3.

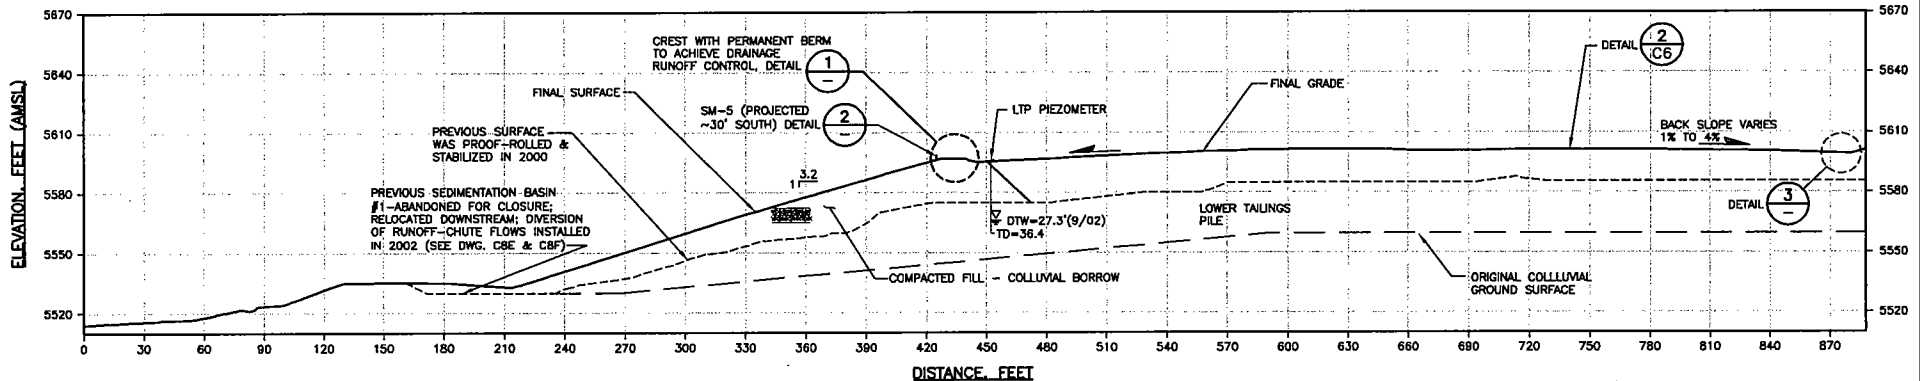
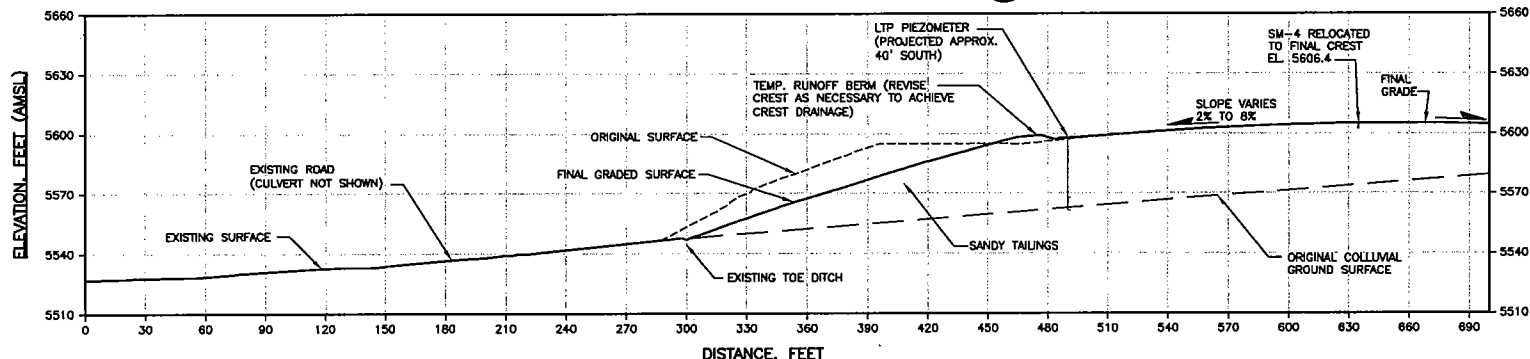
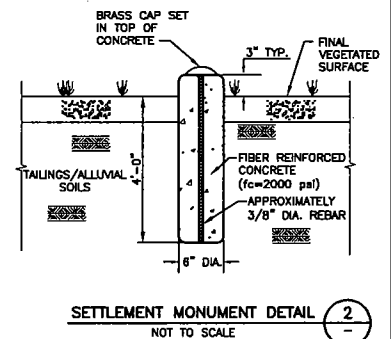
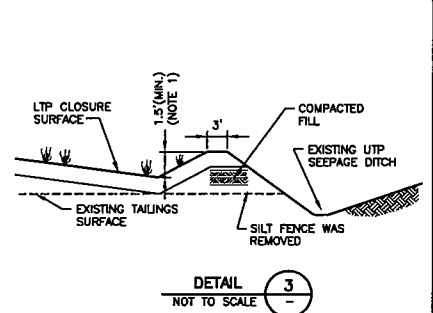
1. RUNOFF DITCHES WERE GRADED AROUND LTP CLOSURE AT A MINIMUM SLOPE OF 0.5% TOWARDS THE EXISTING 24" CMP AT THE NORTH END, OR TO AN OUTFALL AT THE SOUTH END DRAINING TO THE EXISTING ROADSIDE DITCH.

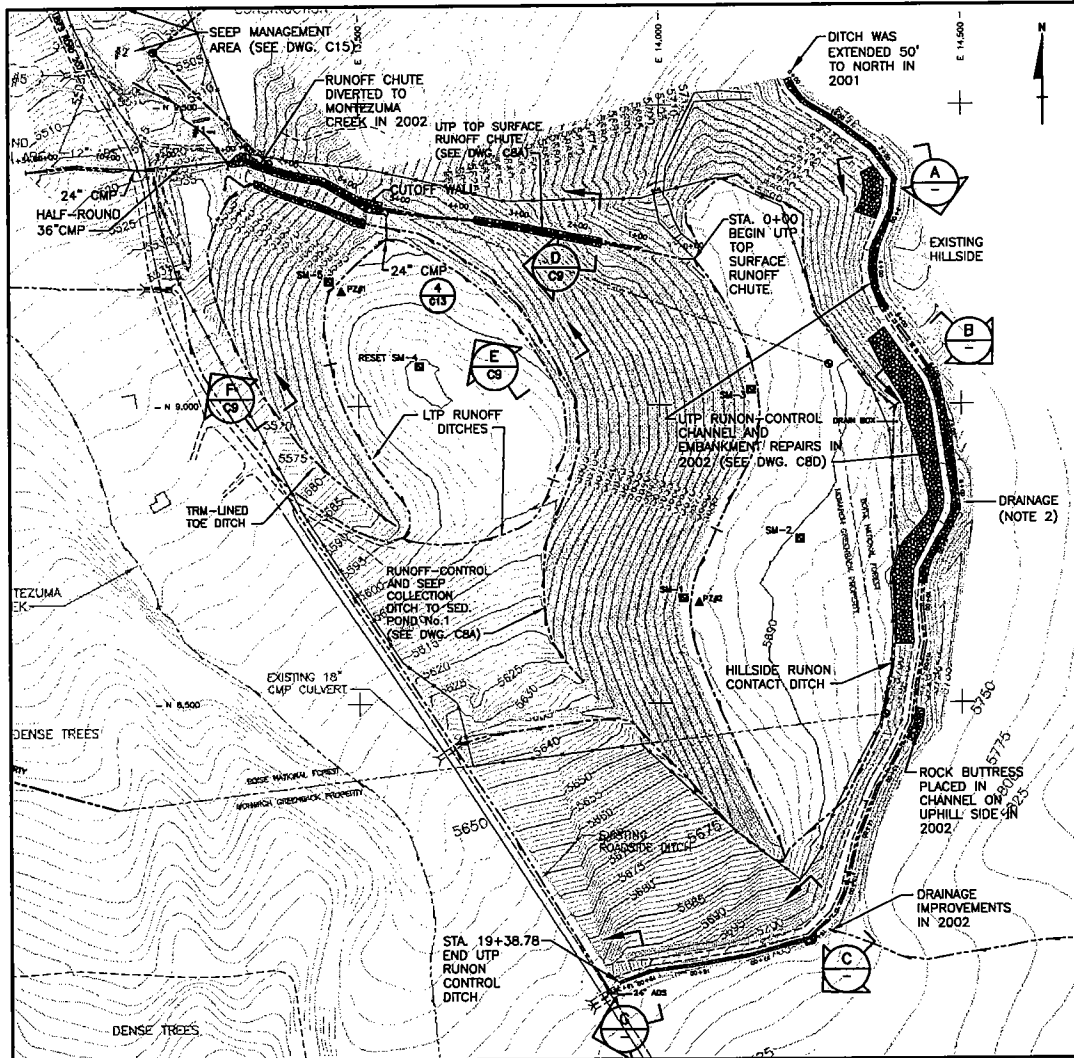
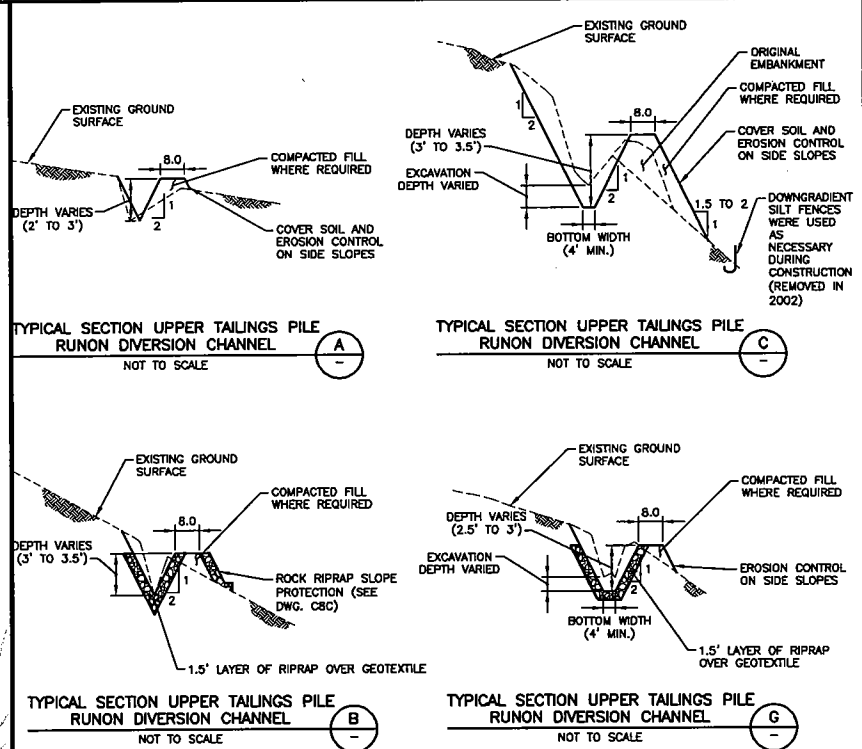
**ST. JOE MINERALS & MONARCH GREENBACK**  
**TALACHE MINE TAILINGS PILE SITE**  
**TAILINGS PILES**  
**RUNON/RUNOFF CONTROLS**  
**PLAN AND TYPICAL SECTIONS**  
 DATE: FEBRUARY 2000 DWG. NO. 6240-C8 REVISION 7

1. RIPRAP WAS USED IN CHANNEL REACHES HAVING GRADIENTS IN EXCESS OF 2%.
2. TEMPORARY EROSION CONTROL DEVICES WERE INSTALLED ON HILLSIDE UPGRADIENT OF RUNON - CONTROL CHANNEL AS DIRECTED IN 2001.
3. THE CHANNEL SUBGRADE WAS EXCAVATED AND PREPARED AS SPECIFIED. OVEREXCAVATION AND REPLACEMENT WITH COMPACTED FILL WAS PERFORMED WHERE NECESSARY AND AS DIRECTED.
4. THE UTP RUNON-CONTROL CHANNEL WAS SUBSTANTIALLY COMPLETED IN 2002. REQUIRES ADDITIONAL MINOR WORK IN 2003.

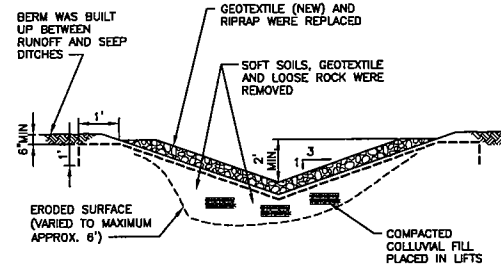
TYPICAL RUNOFF CHUTE  
 REPAIR SECTION  
 NOT TO SCALE

If areas of undercutting or downcutting are observed at runoff chute grade changes or near cutoff walls or diversion points, such areas will be repaired with compacted fill, rock riprap or possibly additional concrete as necessary. Each area will be inspected and recorded to determine the appropriate repair method.

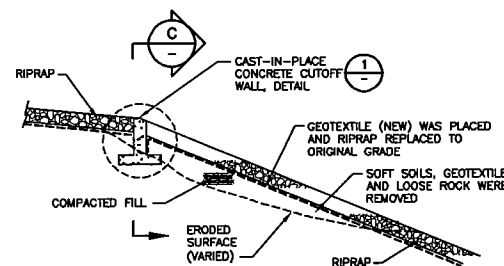
TYPICAL PROFILE OF ERODED  
 AREA ON RUNOFF CHUTE  
 NOT TO SCALE

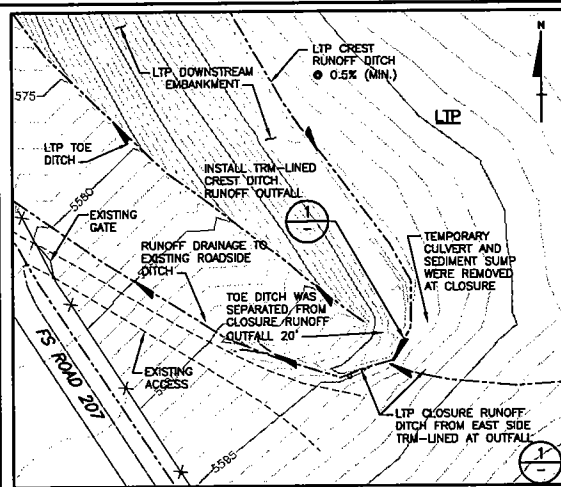
PARTIAL PLAN  
SCALE  
30 0 30 FEET

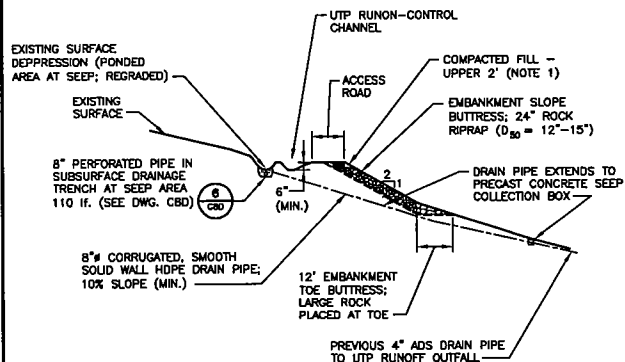
SECTION THROUGH DRAINAGE CULVERT (F)  
SCALE  
30 0 30 FEET

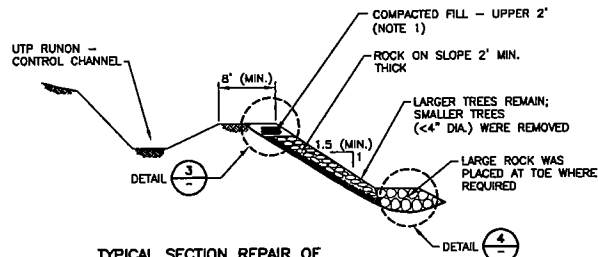
TYPICAL SECTION REPAIR OF UTP RUNON CONTROL DITCH EMBANKMENT (D)  
NOT TO SCALE

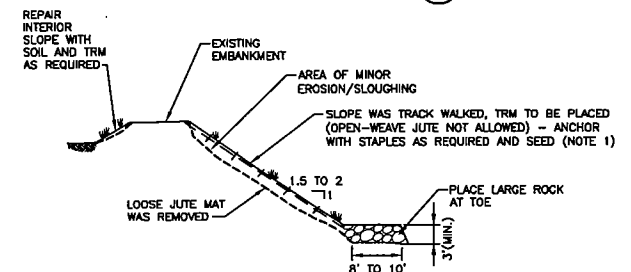
TYPICAL SECTION (E)  
NOT TO SCALE

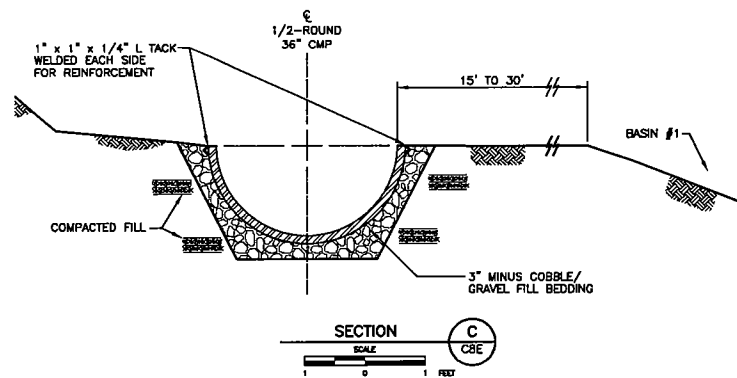
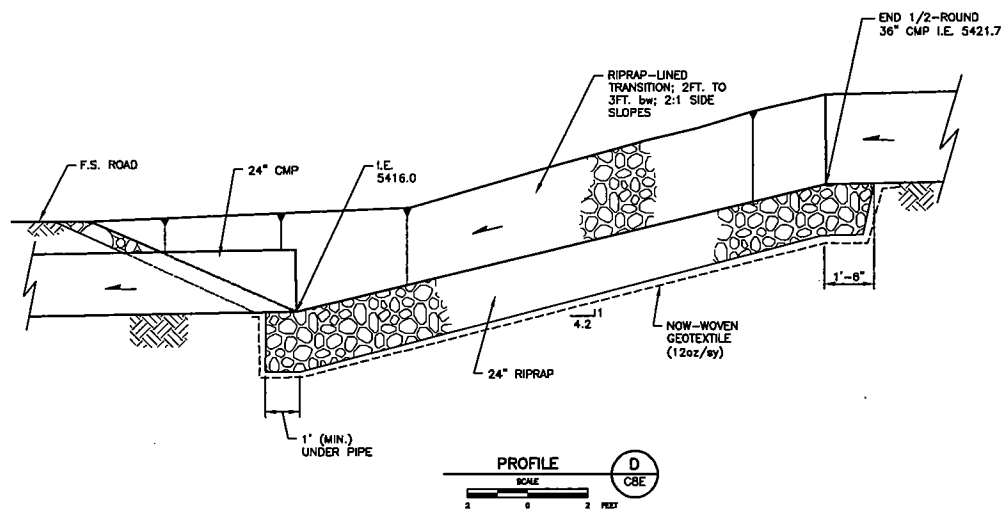
<b>ST. JOE MINERALS &amp; MONARCH GREENBACK</b>			
<b>TALACHE MINE TAILINGS PILES SITE</b>			
<b>TAILINGS PILES NORTH RUNOFF</b>			
<b>DITCH OUTFALL MODIFICATIONS - PLAN</b>			
DATE	SEPTEMBER 2002	DWG. NO.	6240-CBE
REVISION	2

1. CORRUGATED, GALVANIZED STEEL PIPE (ASTM A 760), 16 GAGE THICKNESS, WAS USED.

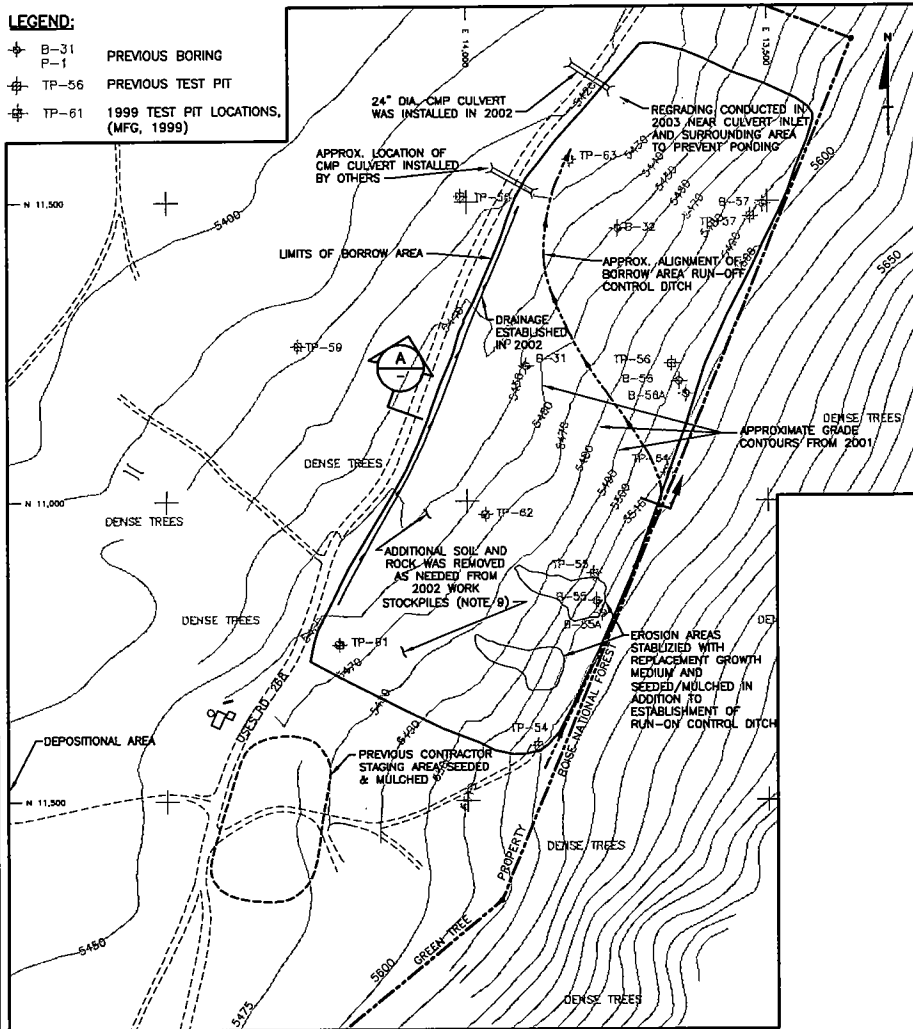
**ST. JOE MINERALS MONARCH GREENBACK**  
**TALACHE MINE TAILINGS PILE SITE**  
**COLLUVIAL BORROW AREA**  
**PLAN AND SECTION**  
 DATE: FEBRUARY 2000 DWG. NO. 6240-C10 REVISION 5

PLAN

9. COLLUVIAL SOILS AND ROCK WERE REMOVED IN 2003 FROM BORROW AREA AS NEEDED FOR SEEP MANAGEMENT AREAS. LARGE ROCK WAS USED AS NEEDED FOR INFILTRATION TRENCHES AT POND #3-#4 AND POND #6.

10. BORROW AREA WAS REGRADED FOLLOWING PLACEMENT OF GROWTH MEDIUM AND SEEDING/MULCHING IN FALL OF 2003.
11. REMAINING SOIL AND ROCK/BOULDERS WERE SPREAD OUT SO THAT NO STOCKPILES REMAINED.

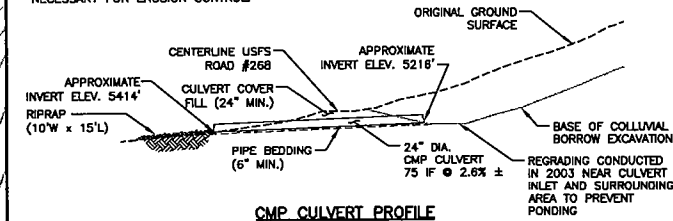
CMP CULVERT PROFILE

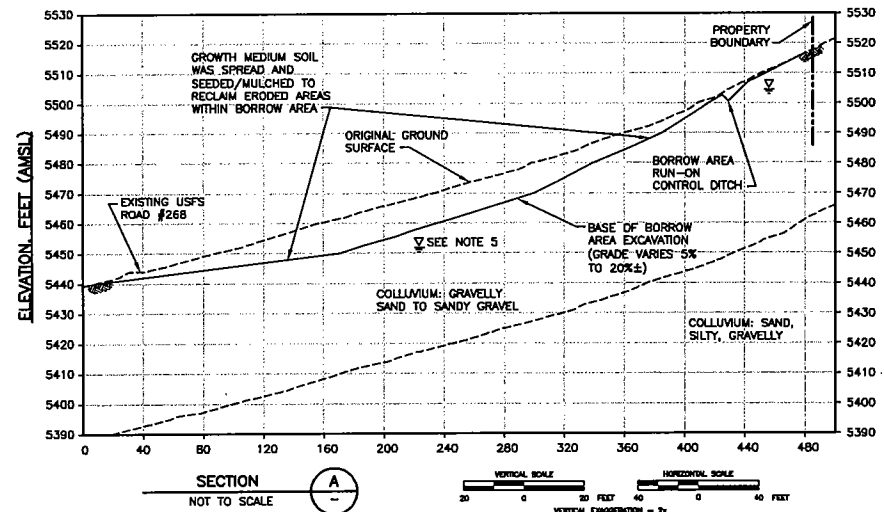
SECTION A-A

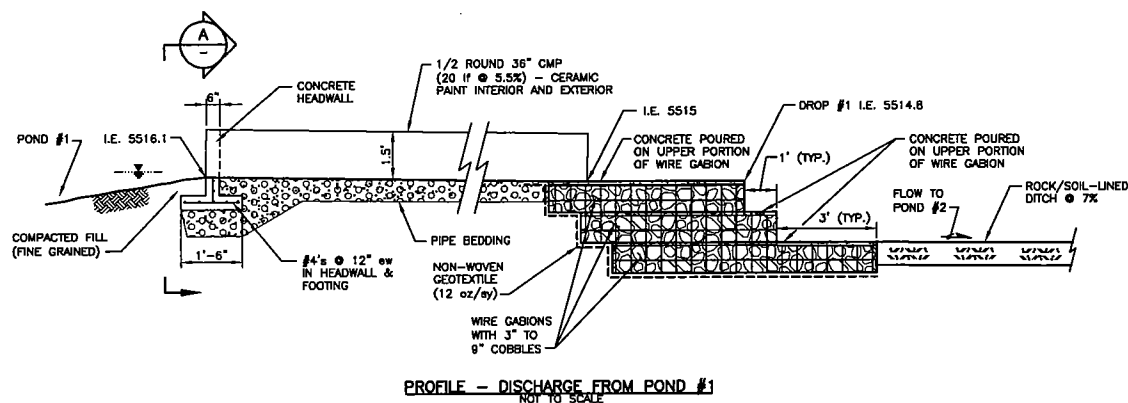
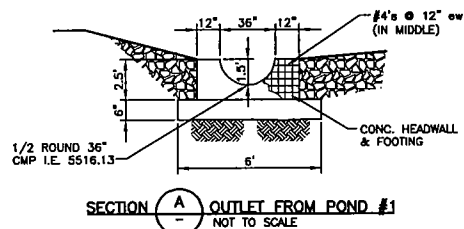
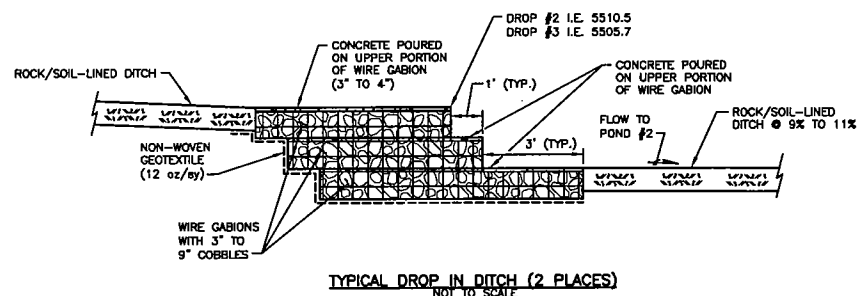
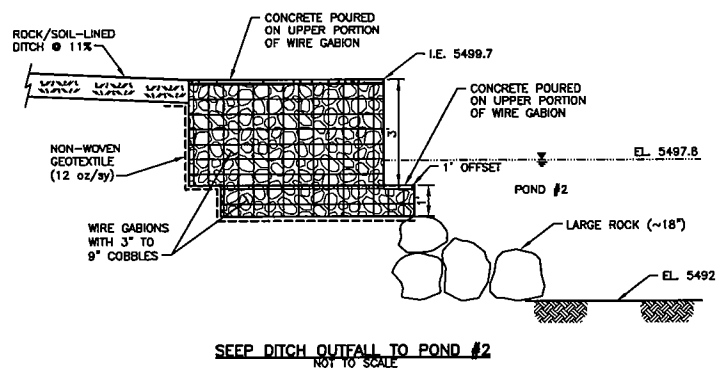
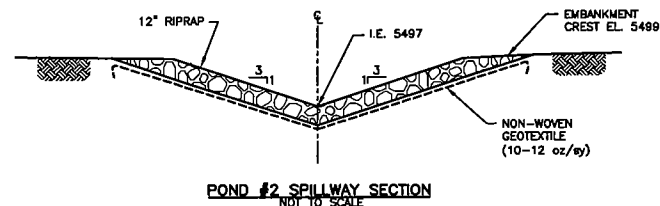
- NOTES:**
1. CONTRACTOR USED WIRE GABIONS WITH 3" TO 9" COBBLES. CONSTRUCTED VERTICAL DROPS AND INFILLED TOPS OF GABIONS WITH CONCRETE, 3" TO 4" TYP.
  2. DITCH AND ASSOCIATED DROPS CONSTRUCTED TO ACHIEVE SURFACE FLOW OF SMALL SEEPAGE FLOW RATES OF 5gpm.
